# Failure Analysis of Tungsten Stud Defects from the CMP Process

**K. Takagi, Y. Kohno**  
ITES Co., Ltd. Shiga, Japan  
**S. Nukii**  
IBM Japan, Ltd.

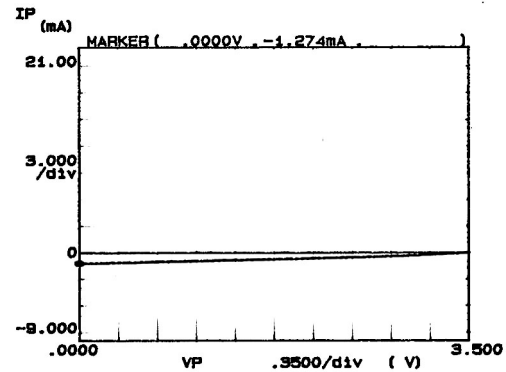
Figure.2 I/O leakage at pad

Electrical characterization at pad level was done to verify the I/O leakage failures. Figure 2 shows the I/O leakage for the same conditions as the LSI tester measurements. The conditions are shown in Table 1. The leakage value was same as measured with the LSI tester.

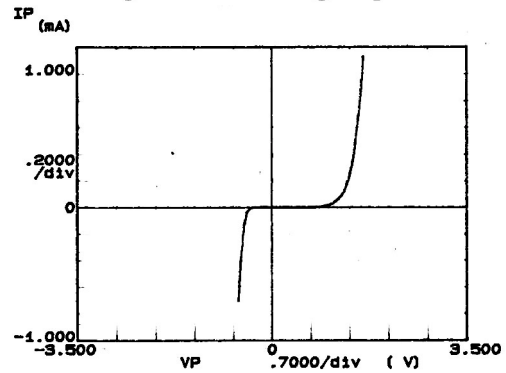
Figure.3 Pad - GND characteristic  
VP = -3.5 V to 3.5 V (sweep)

Figure 3 shows the characteristics of pad-GND, which is normal and figure 4 shows the characteristic of pad-V<sub>1</sub>, which has a short.

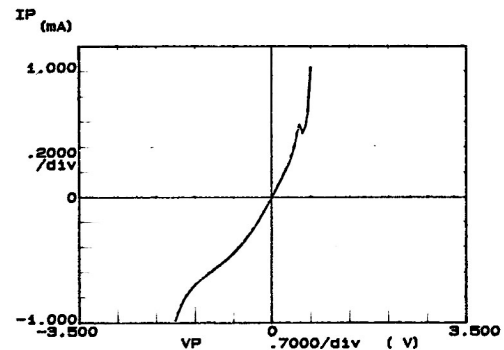
Figure.4 Pad - V<sub>1</sub> characteristic  
VP = -3.5 V to 3.5 V  
(sweep)

From these results, the following modes were considered most likely as the cause of the input leakage:

- 1) A short between an input pad and V<sub>1</sub>
- 2) A leakage path from input pad to V<sub>1</sub> through a P-FET of one of the protective devices

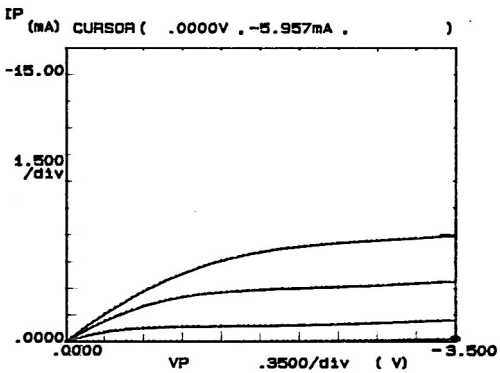
Figure.11 Static characteristic of fail P-FET pair

Current through a good P-FET pair is shown in Figure 9. It is twice as much as from a single P-FET, which is shown in Figure 10. However, for a bad P-FET pair, as shown in Figure 11, the current flow is only half the current of a good P-FET pair. To sum it up, the current of the failed P-FET pair is equal to a single P-FET. This result reveals that one gate of the bad P-FET pair did not turn 'on'.

This indicated that a floating gate caused the input leakage failure, and it was suspected that the cause of the floating gate was an open W stud defect, where the stud connects  $M_1$  to the gate.

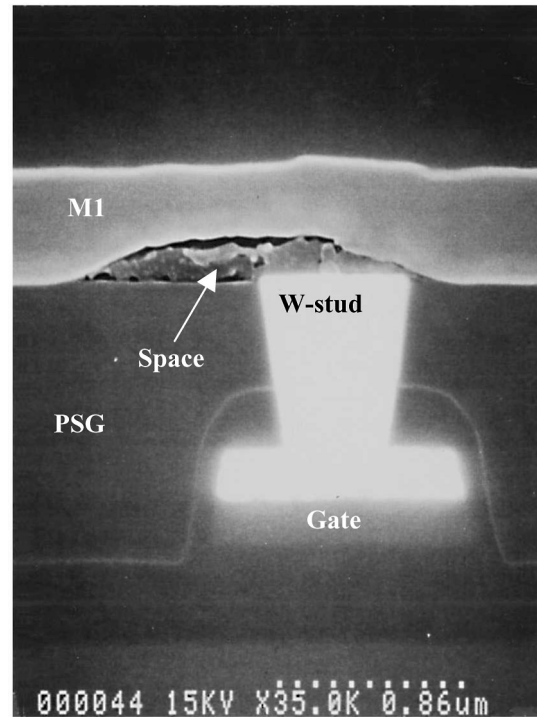
Fig.12 Cross sectional SEM observation

Figure 12 shows the result. It was found that there was a space between the bottom of  $M_1$  and the top of the W stud. Part of the space was filled with FM, which from its contrast seems to be an organic material. This result made it clear that one of the suspicious contacts was open and this caused the gate

to float, but it was unclear whether the FM was originally inside the space or if it was debris from the mechanical polishing.

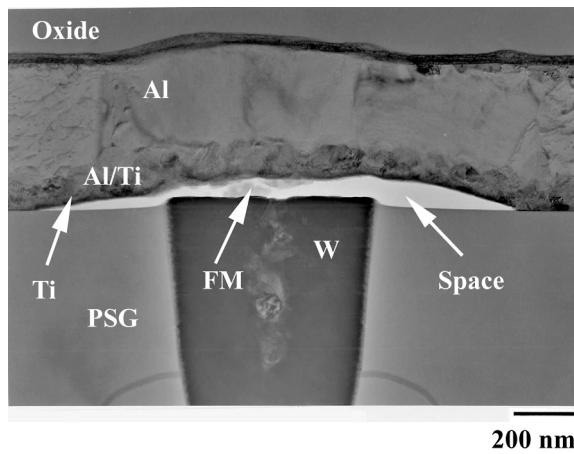
Figure.13 Cross sectional TEM observation

Another open stud was isolated using the same method. This time a TEM specimen was prepared by using FIB to examine a cross-section without artifacts from mechanical polishing. Figure 13 shows the image of a gap. There was a gap at the interface between the Ti liner of  $M_1$  and the W stud, and the FM was clearly observed inside the space. The Aluminum (Al) grains and  $Al_3Ti$  grains appeared normal. From these results, it seemed that the open was traceable to the W CMP process.

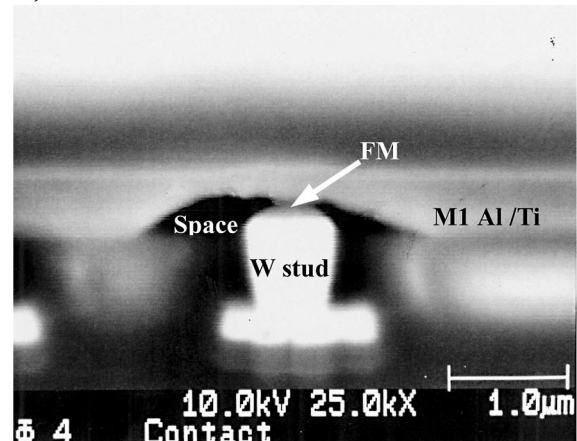
Figure.15 Cross sectional SEM Image of the open stud by FE-AES (tilted at 50 degrees)

numbers of Auger electrons from a sample. Therefore, a large cross-section including the open stud was prepared by FIB milling. The cross-sectional SEM image made using FE-AES is shown in Figure 15. The specimen was tilted at fifty degrees. An Auger survey spectra was obtained from the cross sectional surface of the FM after Ar sputter cleaning. The survey spectrum is shown in Figure 16. Oxygen (O), carbon (C), phosphorus (P), silicon (Si), Al, Ti and W were detected.

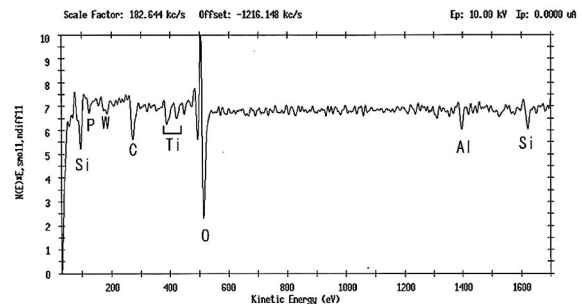
Figure.16 FE-AES survey spectra at the surface of the FM

Considering the high spatial resolution of FE-AES, there was little likelihood of detecting Auger electrons that were generated from elements located far from the analysis point. However, Al, Ti, W can be ignored, because they are the materials of the metal lines themselves. Therefore, O, C, P, and Si were considered to be the elements making up the FM.

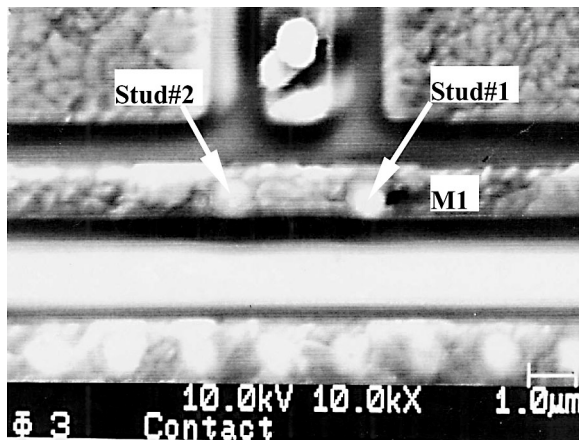
Figure.17 SEM image by FE-AES

Figure 17 shows the SEM image obtained by FE-AES after FIB milling. Stud #1 shows at higher contrast than Stud #2. It seemed that Stud #1 was observed through  $M_1$  and the gap.

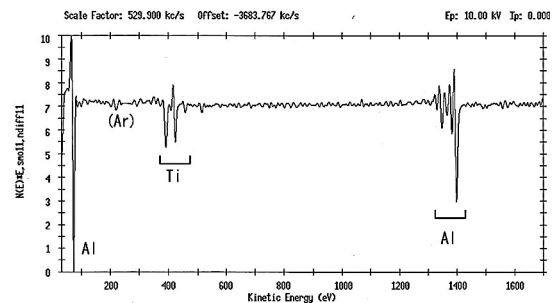
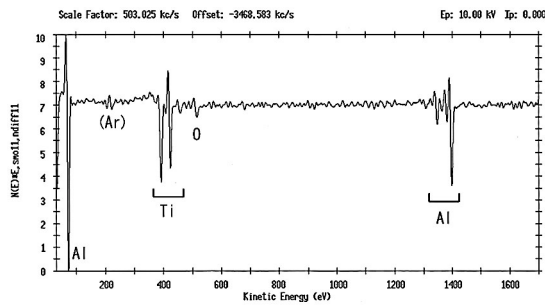
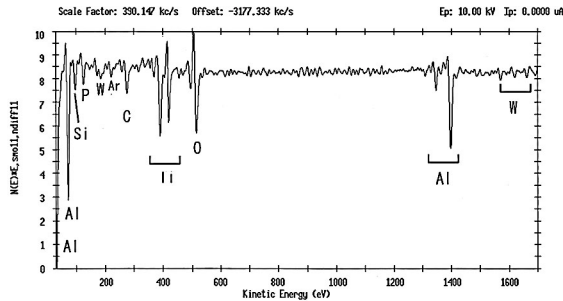
The analyzed interfaces are shown in Figure 18. Figures 19, 20, and 21 show the Auger survey spectra as each interface was exposed through Ar sputtering. Checking the spectra against structure of the metal line ( $M_1$ ), it was clear that the Al and Ti peaks were taken from the material of the metal line. When the Ti peak began to decrease, O, C, P, Si, and W peaks began to appear, and in particular the O peak was very strong. These elements must not exist in the interfaces. The Auger chemical analysis also showed a shift of the Al peak at this time. It was clear that Al oxide, O, C, P, and Si surely existed at the interface between the Ti liner and the space above the W stud. This result agreed with the cross-sectional FE-AES analysis result. The FM was composed of organic material, aluminum oxide, phosphorus compound, and Silicon compounds. These materials seemed to be traceable to the slurry and brushes used in the W CMP process.

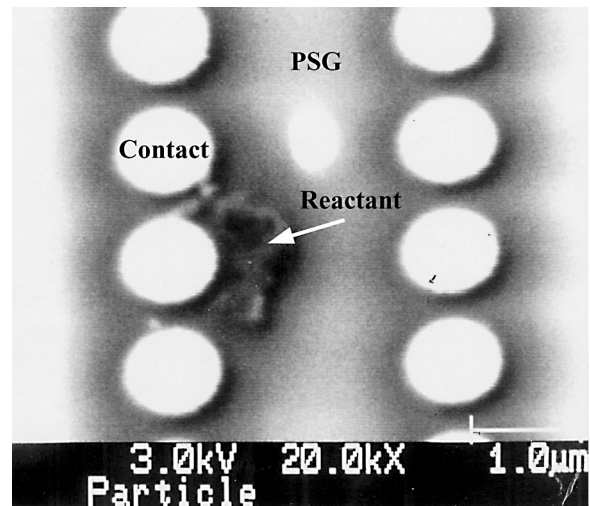
Figure.22 SEM image of the reactant

Problem reproduction experiments and inspections were performed on the W CMP process in the manufacturing line after the failure analysis results had been fed back into the process. It was determined that the unexpected chemical reactants were adhered to the raised edge between the W studs and PSG during the oxide touch up process. It was also found that when the oxide touch up step took more time, more reactants were stuck to the wafer. An SEM image of the excess reactant chemical is shown in Figure 22. An FE-AES spectrum of the reactant is shown in Figure 23. Although the electrical charge-up process disturbed the obtained Auger spectra, O and C were certainly detected from the surface of the reactant. This confirmed that the reactant consisted of organic materials, in agreement with the earlier failure analysis results.

The analysis results were fed back into the W CMP sector. As a result, the material of the cleaning brushes was changed from nylon to PVA (polyvinyl acetate), and the oxide removal quantity was reduced. The process yield had been improved by these actions, showing that the open stud defects were the main cause of the low yield.
