LUXEON® Reliability

Introduction

LUXEON® Power Light Sources represent a revolutionary advance over conventional small signal LED light sources. This application note summarizes the reliability performance of the LUXEON family. The application note discusses general reliability concepts, potential failure modes, and aspects of product reliability that are affected by the customer application.

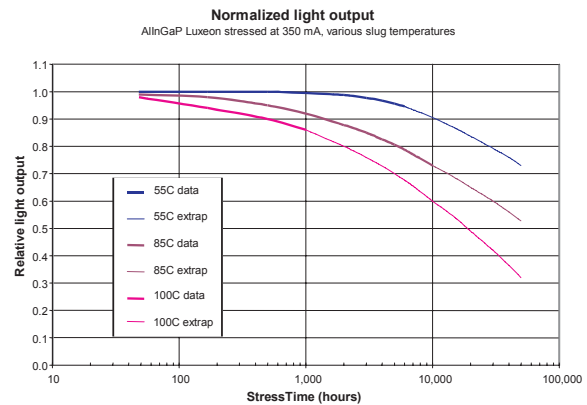
Figure 10.

The rate of light output degradation also tends to increase at higher temperatures when driven at a fixed dc current. Figure 10 shows the lumen maintenance of AllnGaP LUXEONS driven at 350 mA at slug temperatures of 55°C, 85°C and 100°C (junction temperatures of 71°C, 101°C, and 116°C, respectively). Note that the change in light output is expected to increase from -9% to -27% to -40% after 10,000 hours.

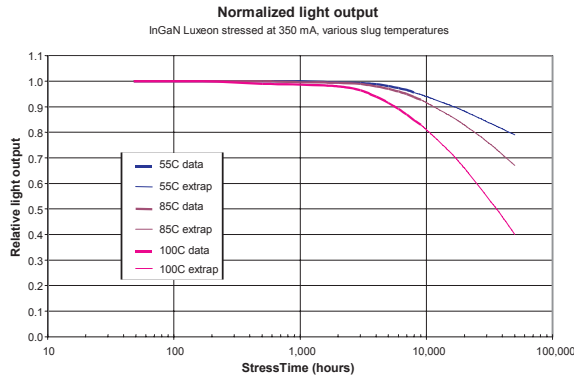
Figure 11.

Figure 11 shows the lumen maintenance of InGaN LUXEONS stressed at 350 mA at slug temperatures of 55°C, 85°C, and 100°C (junction temperatures of 72°C, 102°C, and 117°C, respectively). Note that the light output degradation is expected to increase from -6% to -8% to -19% after 10,000 hours. Figures 10 and 11 show that generally the light output degradation of the InGaN LUXEON is less sensitive to temperature than the AlInGaP LUXEON.
