# Failure Analysis of Tungsten Stud Defects from the CMP Process

**K. Takagi, Y. Kohno**  
ITES Co., Ltd. Shiga, Japan  
**S. Nukii**  
IBM Japan, Ltd.

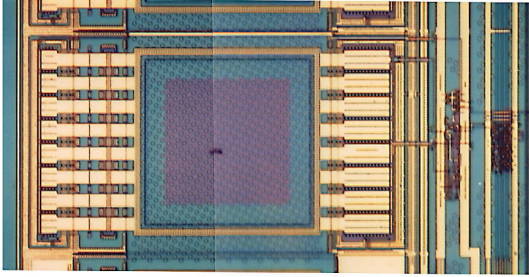
Figure.5 Optical image of Input after M2 removal

Optical observations with planar polishing made clear that M<sub>4</sub>, M<sub>3</sub>, M<sub>2</sub> and M<sub>1</sub> were normal. There was no short between the input line and the V<sub>1</sub> line. The cause of the failure was suspected to be leakage through a P-FET of one of the protective devices. The connections of the input circuit were analyzed.

Figures 5 and 6 show the M<sub>1</sub> level optical image of the input circuits. Figure 7 shows the optical image of the P-FET after M<sub>1</sub> was removed. Figure 8 is the schematic of input circuit that was composed of M<sub>1</sub>

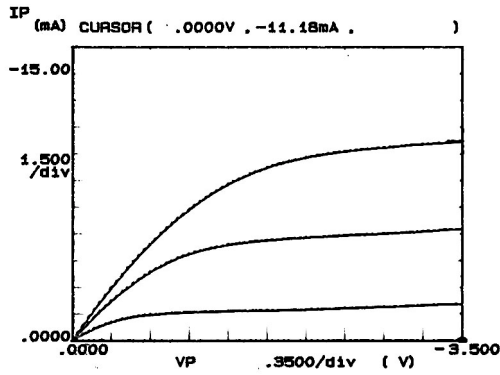
Figure.9 Static characteristic of good P-FET pair

Current through a good P-FET pair is shown in Figure 9. It is twice as much as from a single P-FET, which is shown in Figure 10. However, for a bad P-FET pair, as shown in Figure 11, the current flow is only half the current of a good P-FET pair. To sum it up, the current of the failed P-FET pair is equal to a single P-FET. This result reveals that one gate of the bad P-FET pair did not turn 'on'.

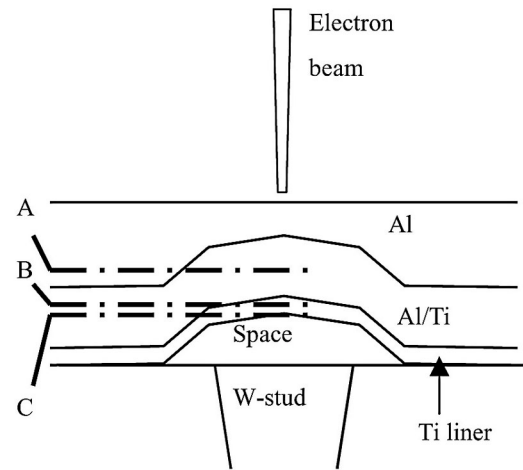
Figure.18 Schematic of cross section at Stud #1

The analyzed interfaces are shown in Figure 18. Figures 19, 20, and 21 show the Auger survey spectra as each interface was exposed through Ar sputtering. Checking the spectra against structure of the metal line ( $M_1$ ), it was clear that the Al and Ti peaks were taken from the material of the metal line. When the Ti peak began to decrease, O, C, P, Si, and W peaks began to appear, and in particular the O peak was very strong. These elements must not exist in the interfaces. The Auger chemical analysis also showed a shift of the Al peak at this time. It was clear that Al oxide, O, C, P, and Si surely existed at the interface between the Ti liner and the space above the W stud. This result agreed with the cross-sectional FE-AES analysis result. The FM was composed of organic material, aluminum oxide, phosphorus compound, and Silicon compounds. These materials seemed to be traceable to the slurry and brushes used in the W CMP process.
